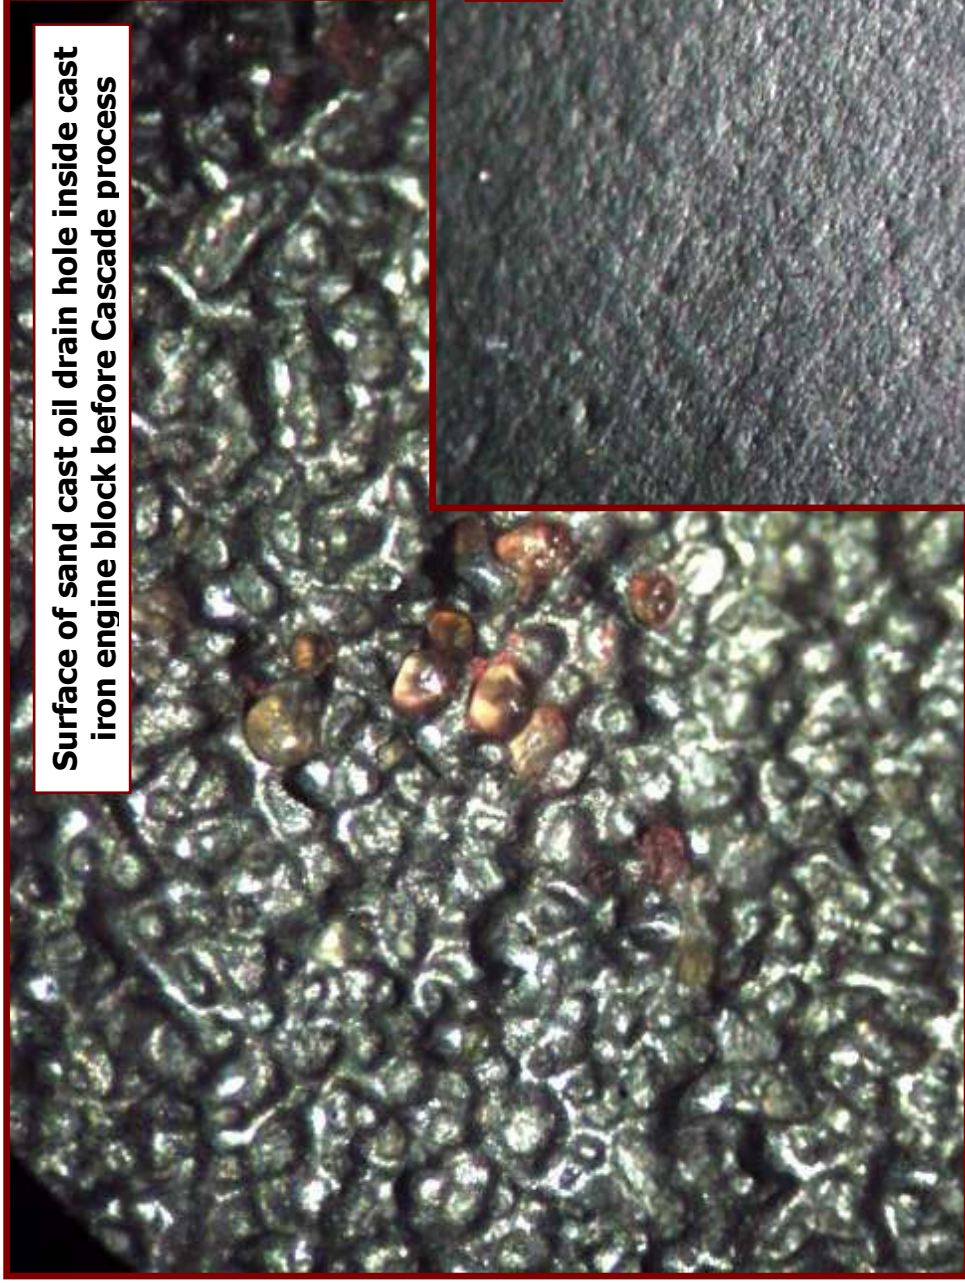
Surface of sand cast oil drain hole inside cast iron engine block before Cascade process

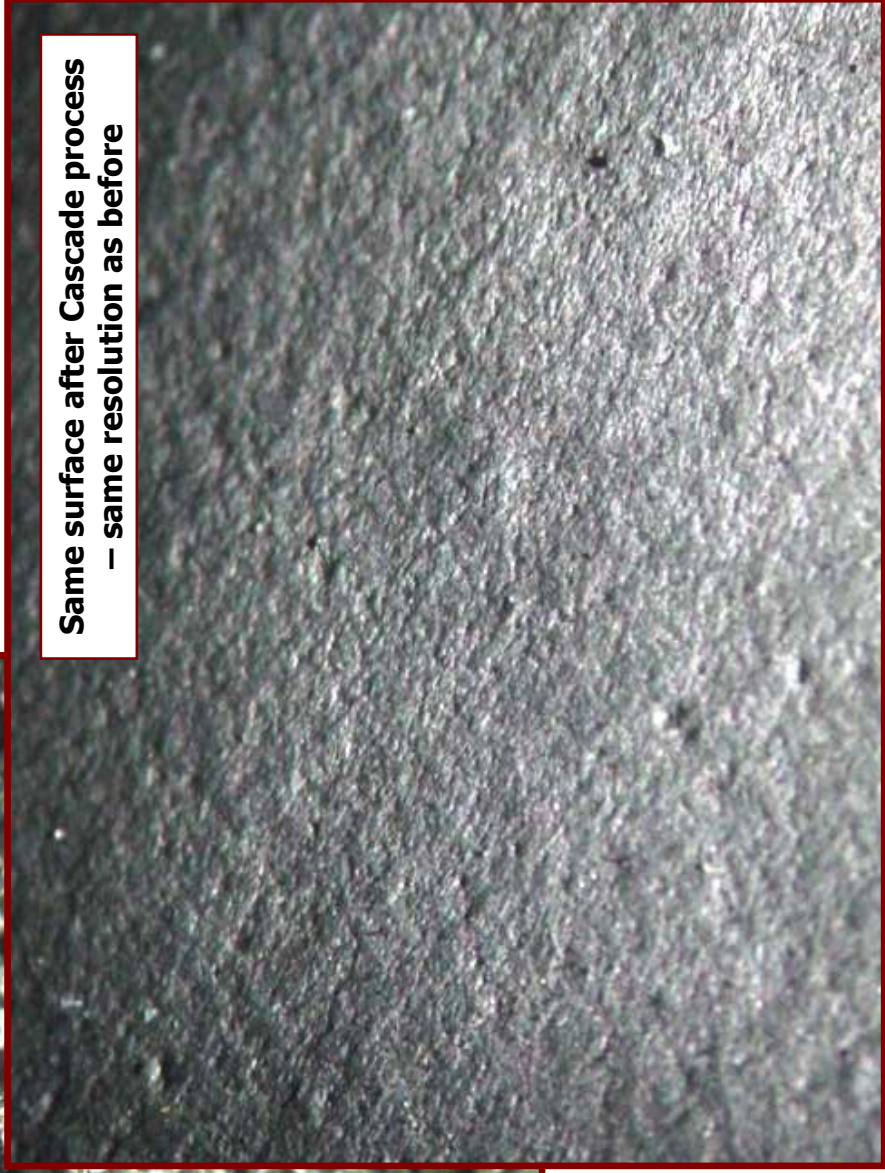
Same surface after Cascade process
– same resolution as before
